eXceed Tx Case Presentation

Courtesy of Dr. V. Kokneava
Moscow, The Russian Federation

Case Details

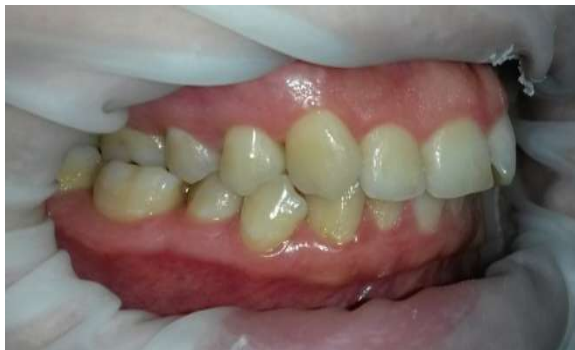
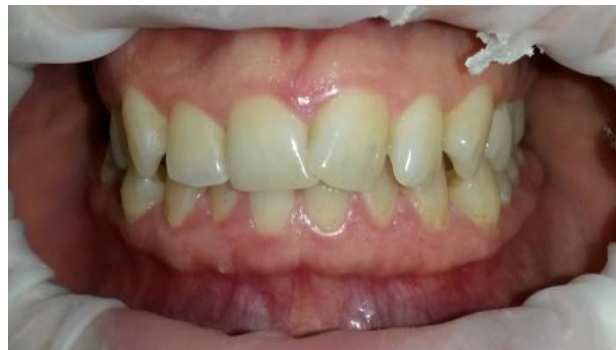
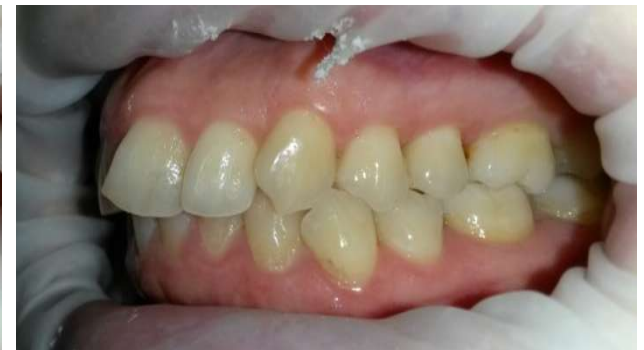
Intra-oral Images

Diagnosis: Cl. 1 dental relations. Overjet 4-5mm, Overbite 50%. Mild upper crowding, moderate lower crowding. #11 and 21 overlap. #16 posterior cross-bite. Mild Lower midline shift.

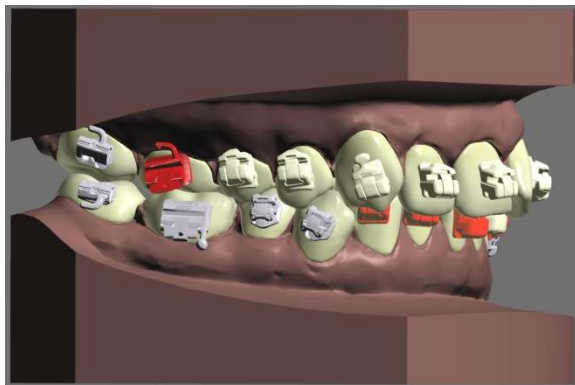
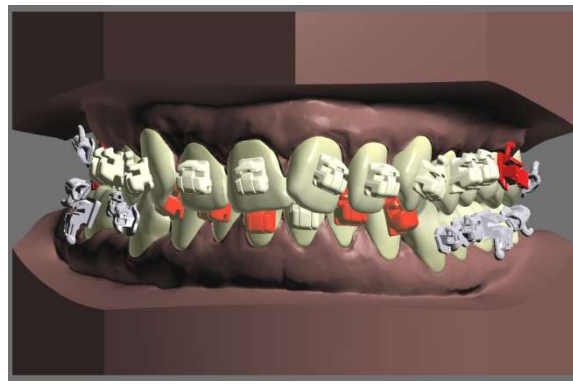
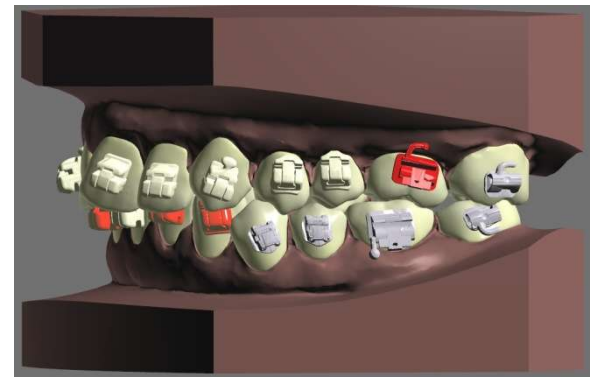
eXceed Tx Virtual Bracketing Plan (06.2014)

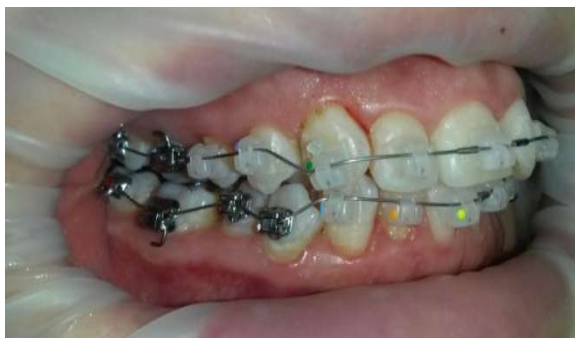
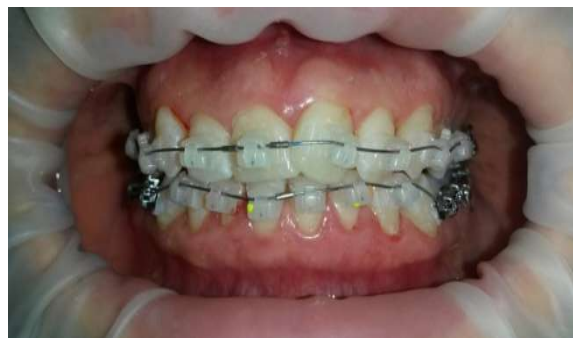
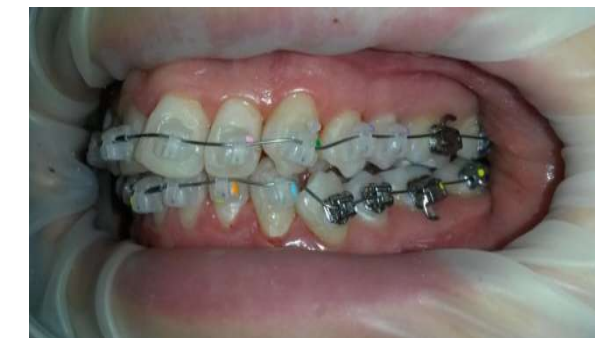
Bracket Placement with eXceed Trays (06.2014)

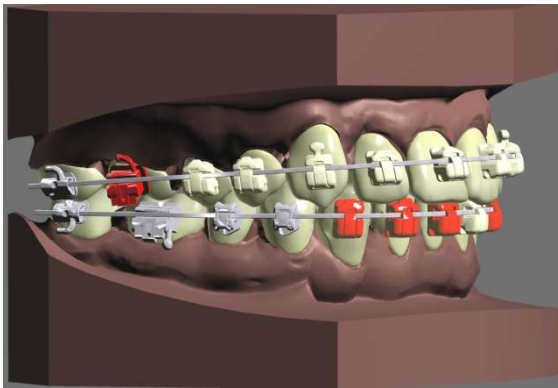
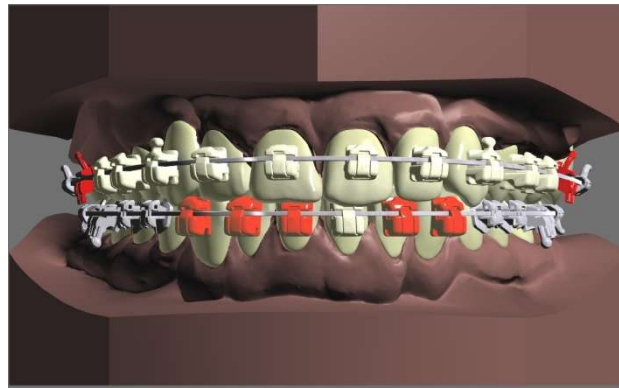
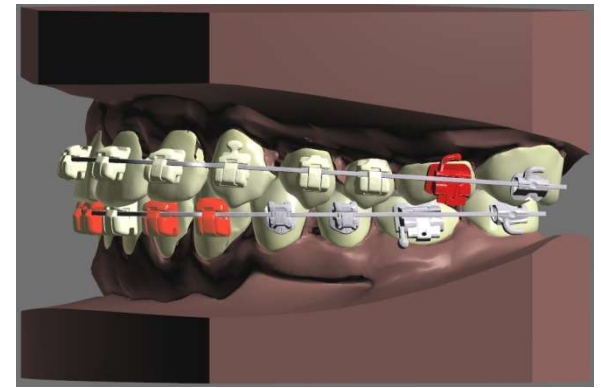
eXceed Tx Virtual Treatment Outcome with Appliances (06.2014)

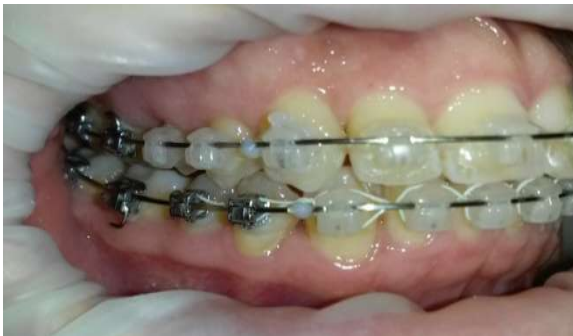
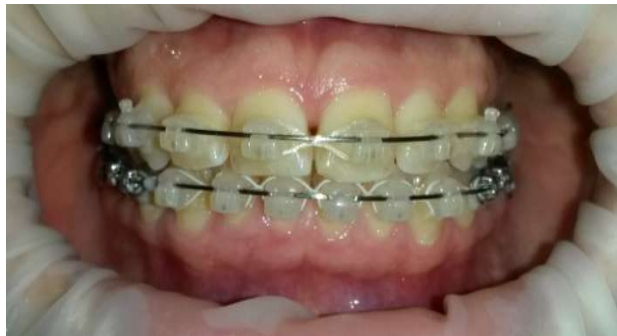
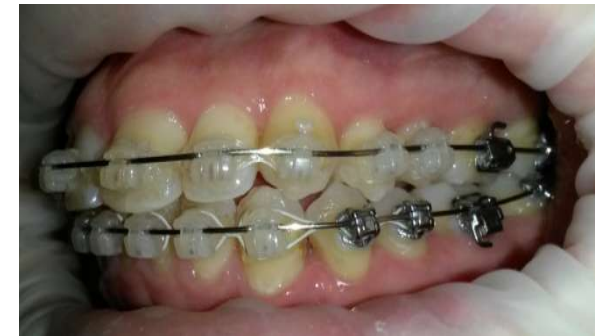
Actual Treatment Outcome with Appliances (10.2015)

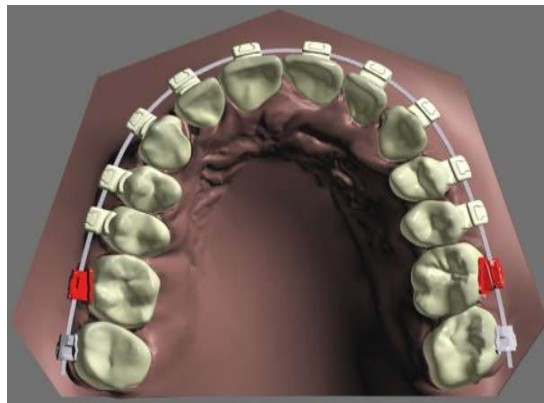
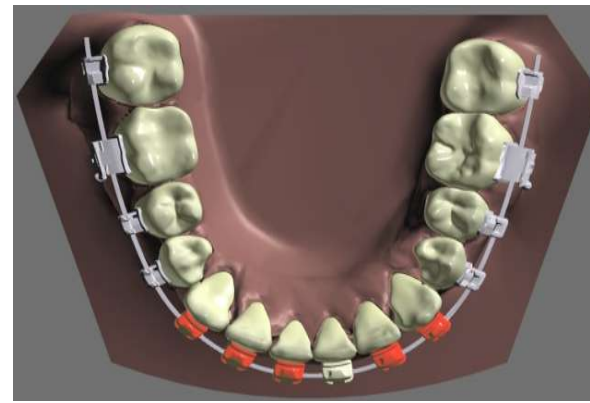
eXceed Tx Virtual Occlusal Outcome (06.2014)

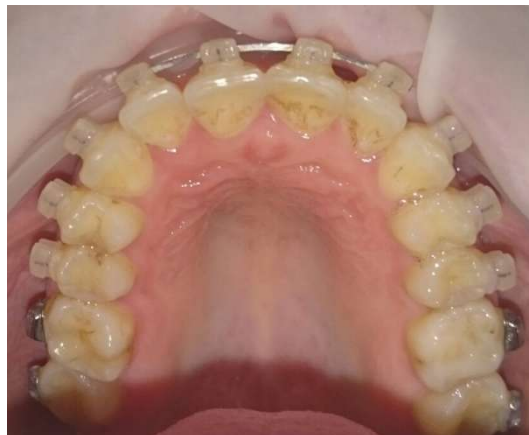
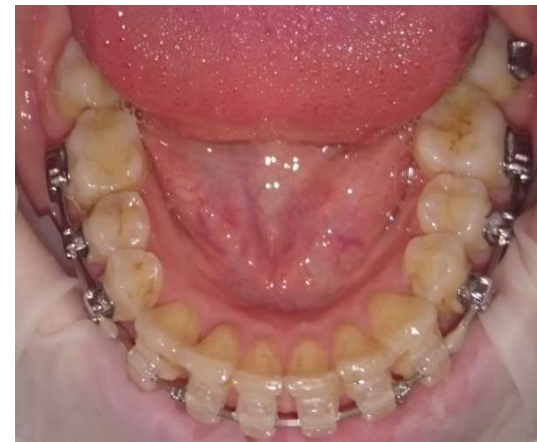
Actual Occlusal Views (10.2015)

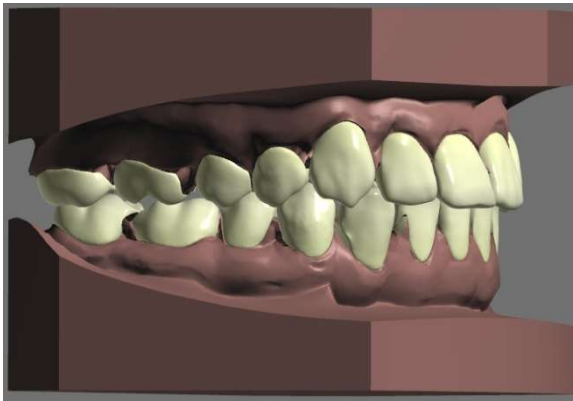
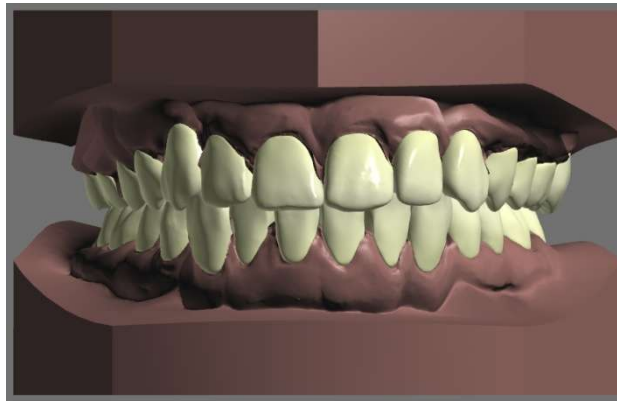
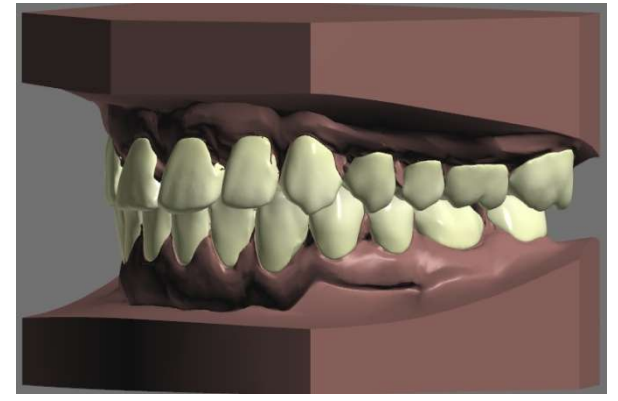
eXceed Tx Virtual Outcome – w/o appliances (06.2014)

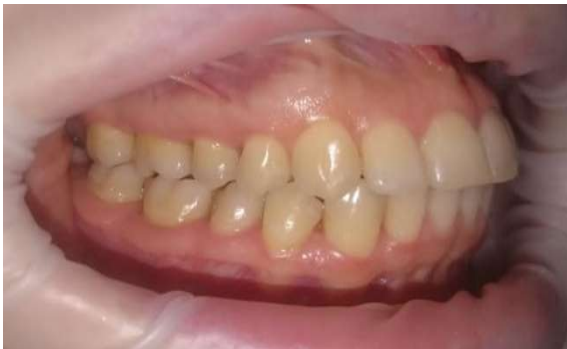
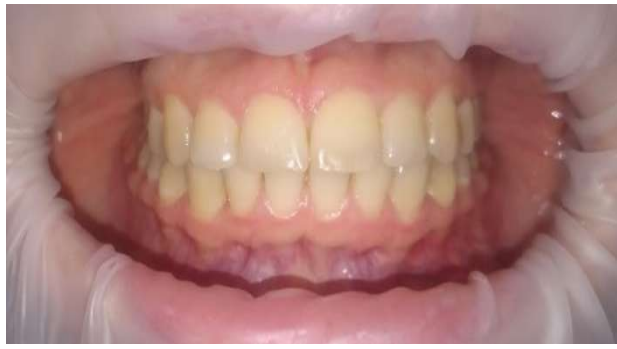
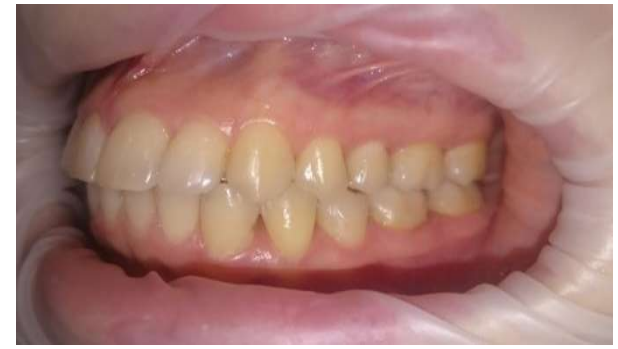
Actual Outcome – w/o appliances (10.2015)
